SERVICE BULLETIN NO. MSB1078-151/2

1.4 Subject:

ATA - Code: 61 Propeller

1.5 Reason:

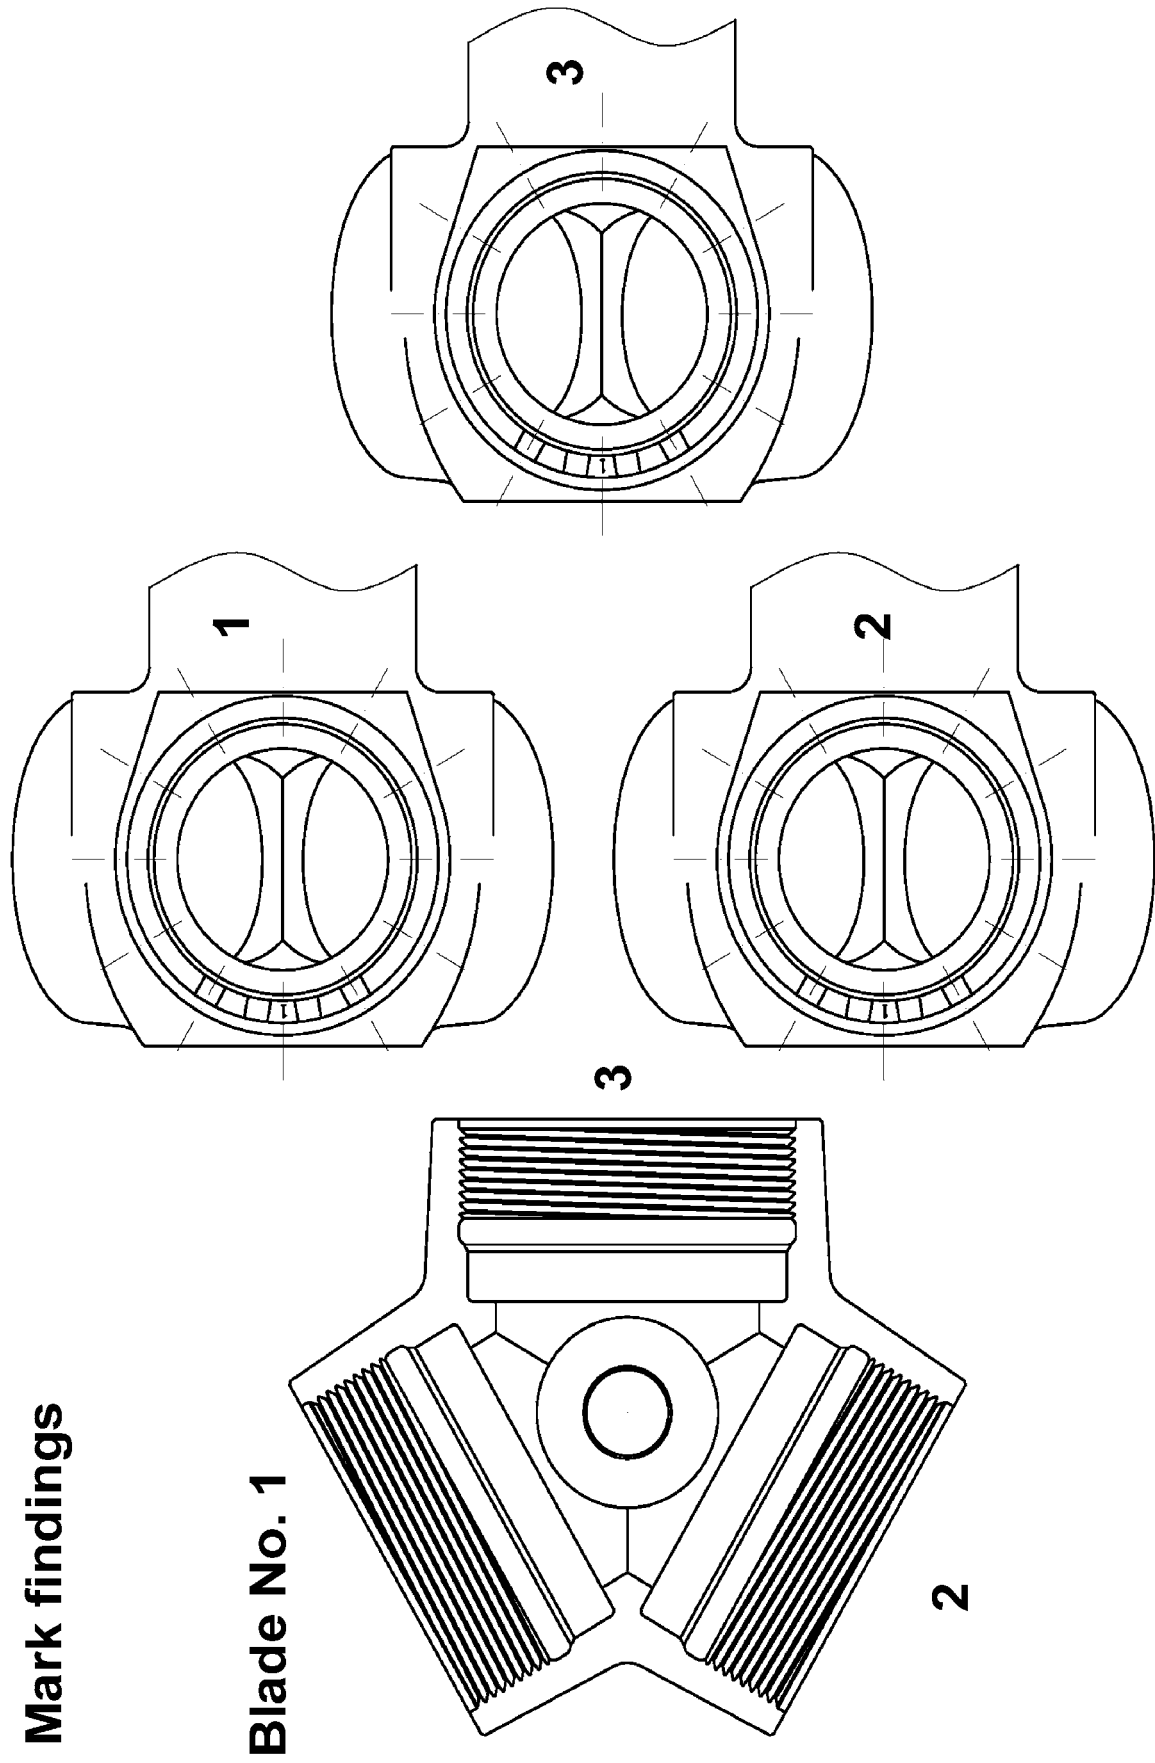
Note findings in Fig. 1

Mark findings
