SERVICE BULLETIN NO. MSB1078-186/3

G 115E all S/N
G 115EG all S/N

ATA-Code: 55-20 Elevators and Trim tab
 Inspection of elevator trim tab arm

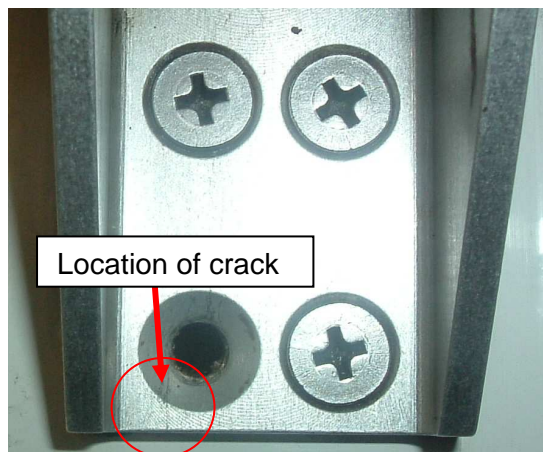
Fig. 1

Grob received a report from a fleet operator that an elevator trim tab arm P/N 115E-3758 was found cracked from a rear mounting hole (either L/H or R/H) to the rear edge of the trim tab arm.

Investigation of defective parts revealed corrosion cracking as cause for cracks. To prevent future cracking, the Trim Tab Arm 115E-3758 is replaced by 115E-3758/1, which is manufactured from an alloy resistant to corrosion cracking. In addition to that, shaping is improved and a paint coat is applied.

1.8.7 If a crack is confirmed, the trim tab arm has to be replaced by a new item.

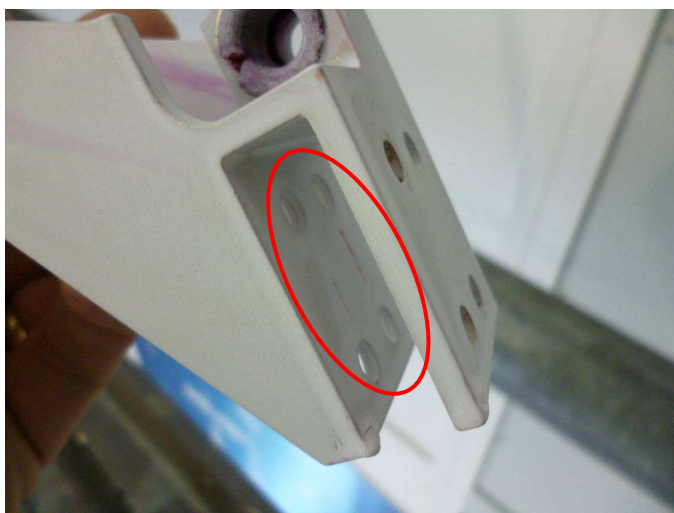
Fig. 2

Dye penetrant check of defective items revealed, that a visual inspection of an installed item mandated with MSB1078-186 at original issue may not be sufficient to detect every crack on the bracket (Fig. 2).

Therefore a dye penetrant check or more significant NDT of the dismantled parts has been mandated by MSB1078-186/1 to ensure safe operation until the terminating action will be accomplished.

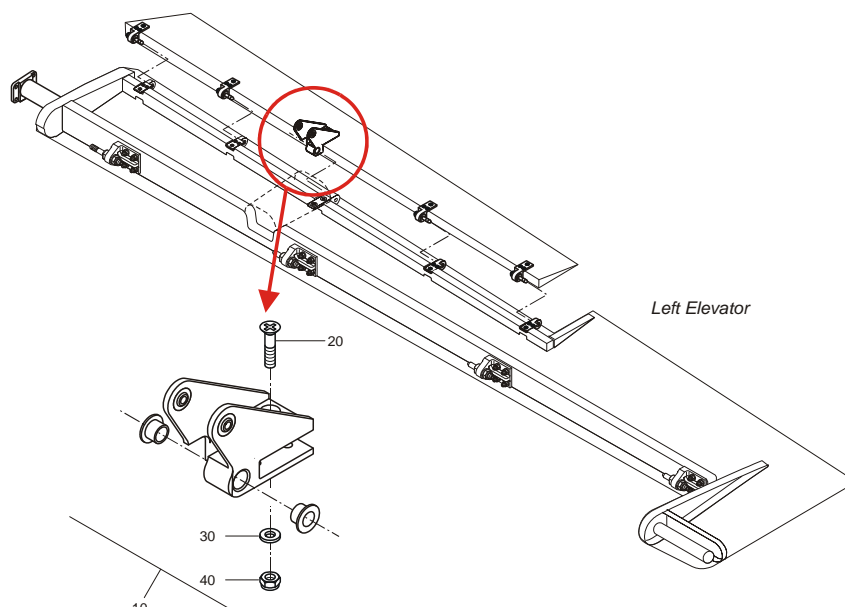
Fig. 3

- 1.8.1 Ensure that the aircraft is safe for parking I.A.W. G 115E AMM chapter 10-10 and G 115EG Job Guide in analogy.
- 1.8.2 Inspect elevator trim tab operating arm for signs of cracking, especially both upper and lower surfaces from the rear bolt mounting holes to the rear of the operating arm.
- 1.8.3 Remove trim tab I.A.W. G 115E AMM chapter 55-20 para. 3B and G 115EG Job Guide in analogy
- 1.8.4 Remove trim tab arm (item 10 in Fig. 3) by removing nut, washer and bolt (item 20, 30, 40 in Fig. 3)

1.8.8 Install trim tab arm P/N 115E-3758 using bolt, washer and new locking nut (item 20, 30, 40 in Fig. 3). Apply correct torque value I.A.W. G 115E AMM chapter 20-10 and G 115EG Job Guide in analogy.

1.8.14 Install new trim tab arm **P/N 115E-3758/1** (item 4 of List 2.2) using bolt, washer and new locking nut (item 20, 30, 40 in Fig. 3). Apply correct torque value I.A.W. G 115E AMM chapter 20-10 and G 115EG Job Guide in analogy.
