Subject: Inspection of the engine mounting frame for abraded areas

Concerned: G 109B, all serial numbers

Urgency: not later than 31. December 1995

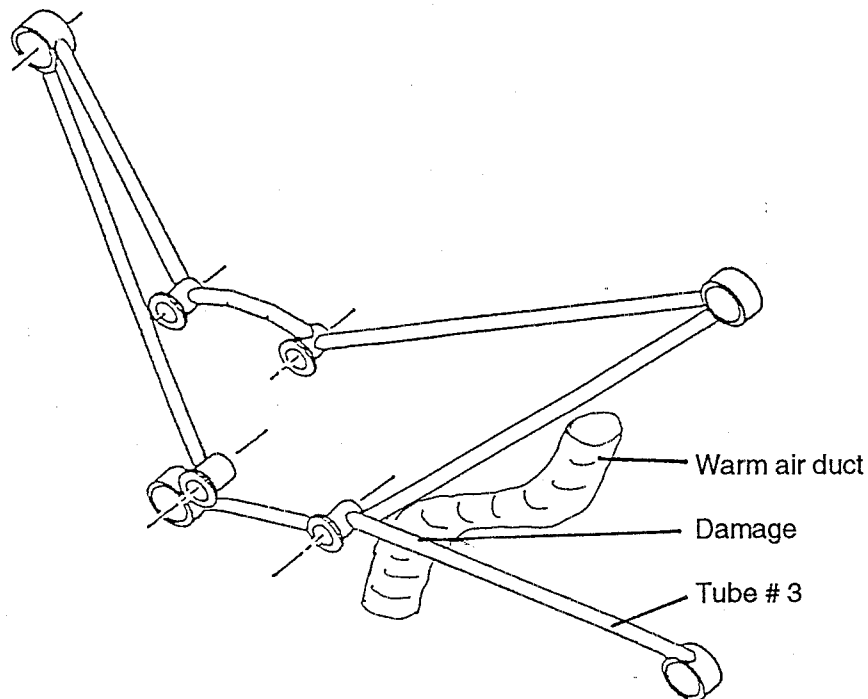
Procedure: Some isolated cases have been reported to GROB of abraded areas on the engine mounting frame. The abrasion forms notches on tube # 3 of the engine mounting frame. These notches are parallel to the tube and are caused by the steel spiral of the warm air duct running from the heat exchanger to the LH carburetor rubbing on the mounting frame (see sketch).
In the cases which have come to our notice, the abrasion has arisen on privately maintained aircraft on which an excessively long warm air duct was installed.

- Action:**
1. Inspect tube # 3 of the engine mounting frame for abrasion.
 2. If abrasion is not detected, no further action is necessary.
 3. If abrasion is detected, proceed as follows:

- (a) If the abrasion is of a minor nature (paint scratched off), remove any corrosion from the area and remove dust. Degrease the tube and apply a protective anti-corrosion coat. Shorten the warm air duct or replace it, if damaged.
- (b) If the abrasion is more severe (up to a depth of 0.7 mm), provisionally protect the engine mounting frame as described in para. 3. (a) and perform final repairs in accordance with para. 4 not later than 31.12.1995.
- (c) If the abrasion is deeper than 0.7 mm, repair the engine mounting frame immediately in accordance with para. 4.

Because the repair must be performed in a welding jig, the engine mounting frame can only be repaired by GROB. Return the degreased mounting frame to GROB together with the attached form.

- 5. In addition, inspect all tubes of the engine mounting frame which may be subject to abrasion and protect where necessary with rubber tubes which have been cut open. Attach the rubber tubes to the mounting frame using Ty-raps.
