SERVICE BULLETIN NO. MSB 315-75  
SERVICE BULLETIN NO. MSB 817-53  
SERVICE BULLETIN NO. MSB 869-26

**1.4 Subject:**

ATA-Code:                      27-10, 27-30  
Aileron Control, Elevator Control

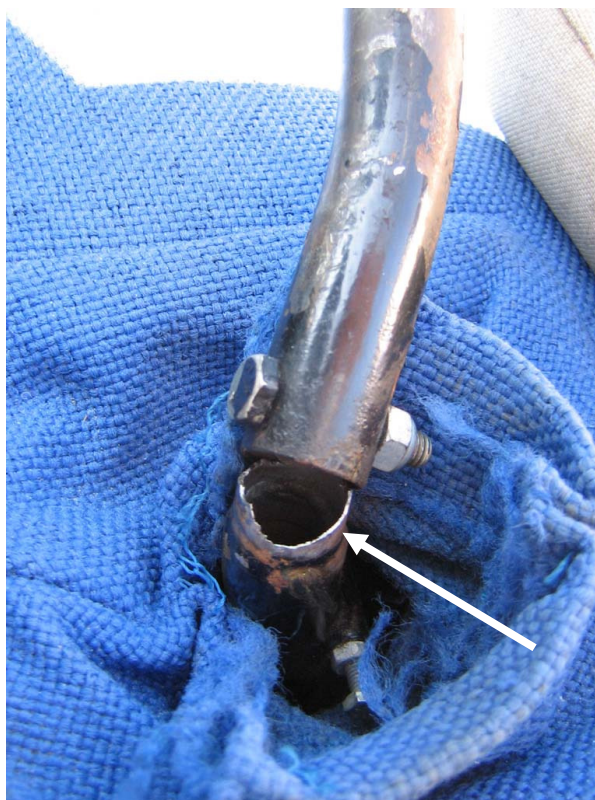
GROB received a report that a rear control stick (welded design) failed on a G 103 TWIN II after about 2600 flight hours.

Although no extensive investigation (metallurgical investigation) could not be performed up to now, a one-time inspection of the rear control stick respectively the RH stick on G 109/ G 109B (same design standard than on the concerned type) is mandatory as a precautionary action to find possible, unnoticed damages and/ or corrosion.

- 1.8.1 Remove control stick cover and release attachment bolt and remove upper control stick.
- 1.8.2 Inspect upper and lower part of the control stick for damage and corrosion.

- 1.8.3 De-rig aircraft and remove control stick unit as far as required.
- 1.8.4 Determined damages or corrosion must be removed in the approved range I.A.W. "Aircraft Inspection and Repair FAA AC 43.13-1A" or new parts must be installed.

- 1.8.5 Re-install control stick unit. If necessary use new attachment parts.
- 1.8.6 Install control stick. Apply and tighten attachment bolt. The standard torque is to be used.
- 1.8.7 Check controls for free and easy movement for correct sense of deflection.
