Subject: Inspection of the BENDIX-magnetos at the GROB 2500 engine

Concerning: G 109B, as of S/N 6200

Urgency: within the next 25 flight hours

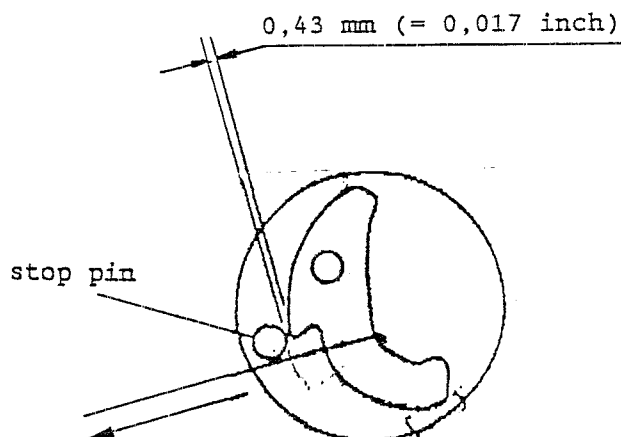
Procedure: During engine inspections too less clearance between flyweights and stop pin has been found.

- a. Pull the flyweight outwards by using a proper tool (for example a stiff, bended wire), measure the clearance and note the value. The clearance must have a minimum of 0,43 mm (=0,017 inch).
 - b. Repeat the measurement for the second flyweight.

Warning: If the clearance is less than 0,43 mm (=0,017 inch), further operation of the engine with this magneto is not allowed, and the manufacturer must be contacted immediately.
