SERVICE BULLETIN NO. MSB 817-50

1.4 Subject:

ATA-Code: 24-10
 DC - Generation

G 109B

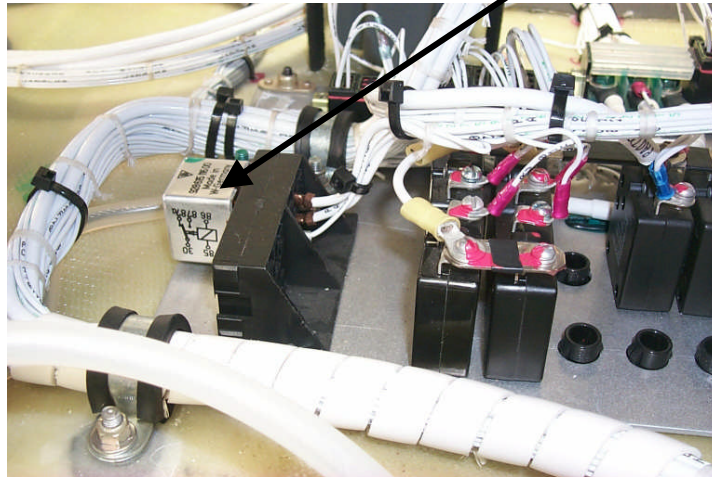
GROB received isolated reports, that relay 6ED was found damaged due to overheating. The relay 6ED is located in the lower RH cockpit instrument panel. Possibly, installation of additional optional electrical equipment may heat up the relay, failure of the lighting system or load bus may result. To cater for increased electrical load the installation of a 30A relay becomes mandatory.

- 1.8.1 Ensure that the aircraft is safe for parking I.A.W. MM.
- 1.8.2 Lower RH cockpit instrument panel and locate relay socket 6ED.

- 1.8.3 Remove and discard relay 6ED.
- 1.8.4 Examine all adjacent wiring for damage and / or signs of over heating. Damaged wiring is to be replaced.
- 1.8.5 Install new relay 6ED P/N V23134-A52-C643.
- 1.8.6 Install and secure RH cockpit instrument panel.
- 1.8.7 Do a functional check.
