SERVICE BULLETIN NO. RSB 817-77

ATA-Code: 79-20 Oil Cooler and Oil Thermostat
Modified oil-cooler bracket

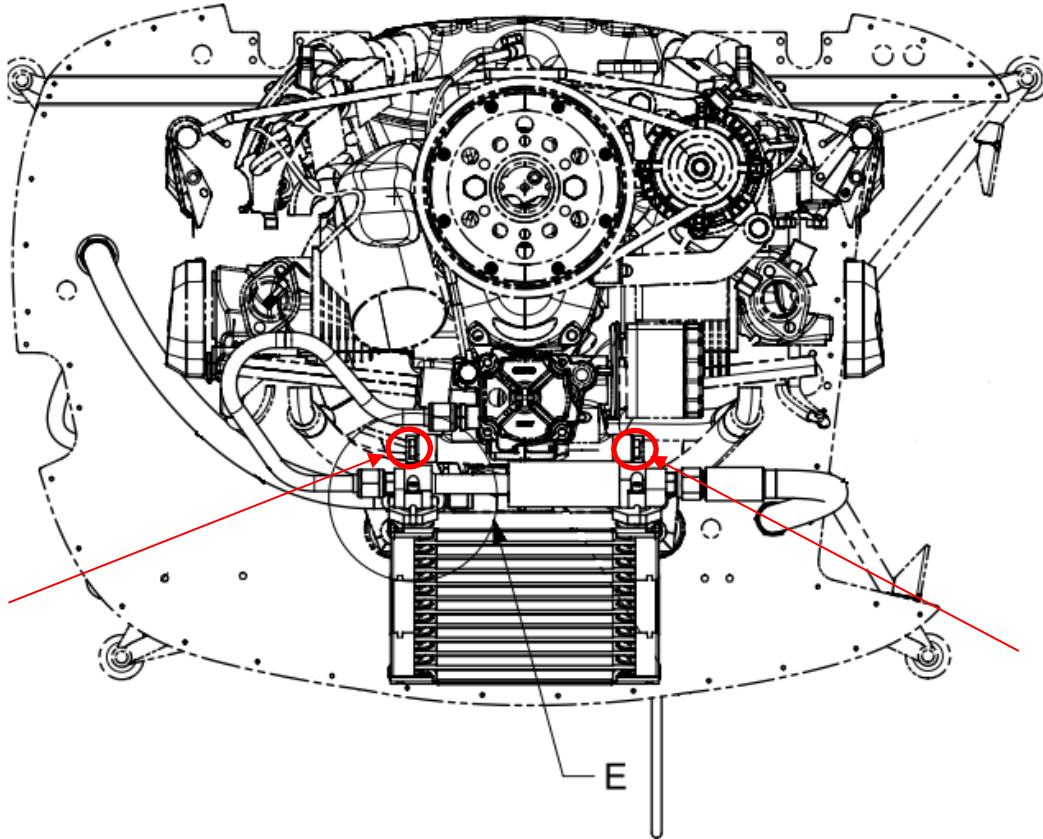
Figure 1 Overview Engine

The weld on the oil cooler adapter that holds the oil cooler can be modified to improve durability. This Service Bulletin is intended to improve the reliability and service life of the oil cooler adapter. The configuration of the aircraft is affected by this Service Bulletin.

- 1.8.1 Make the aircraft safe for parking, refer to AMM Chapter 10-10.
- 1.8.2 Remove the L/H and R/H cowlings, refer to AMM Chapter 71-10.
- 1.8.3 Remove the old adapter weld assy, refer to Figure 1 and keep the bolts and washers.

- 1.8.4 Install the new adapter weld assy R/H, item 1 of list 2.2.
- 1.8.5 Secure the highlighted R/H bolt, refer to Figure 1, with screw locking adhesive LOCTITE 243 (GS513007).
- 1.8.6 Install the new adapter weld assy L/H, item 2 of list 2.2.
- 1.8.7 Secure the highlighted L/H bolt, refer to Figure 1, with screw locking adhesive LOCTITE 243 (GS513007).
- 1.8.8 Install the L/H and R/H cowlings, refer to AMM Chapter 71-10.
- 1.8.9 Release the aircraft back into service according to national requirements.
