SERVICE BULLETIN NO. MSB1078-169

ATA-Code: 52-10 Canopy

Inspection of the canopy lock

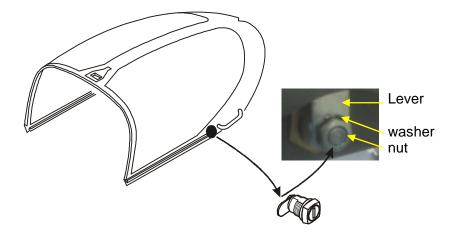
Grob received a report where at several aircraft the locking nut (see Fig. 1) of the canopy lock was found loose or missing. Therefore also the toothed washer and the locking lever detached from the barrel-lock. This Service mandates a one-time inspection for tight fit and the securing of the locking nut using Loctite.

- 1.8.1 Ensure that the aircraft is safe for parking I.A.W. MM chapter 10-10.
- 1.8.2 Move the canopy full aft.
- 1.8.3 Check large nut attaching the lock (Fig. 2, item 18) and the small nut attaching the lever to the barrel for tight fit.

- 1.8.4 Loose nuts shall be secured using Loctite 243 (GS GROB-513007). Replace missing or defective parts.
- 1.8.5 Release aircraft back to service.
