- Subject:** Inspection of the cylinder head valve seat
- Concerned:** Aircraft Engine GROB 2500 E1/D1, all S/N's
- Urgency:** Every 500 hours during the 500 hours inspection or at 100 hours (refer to Remark 2.)

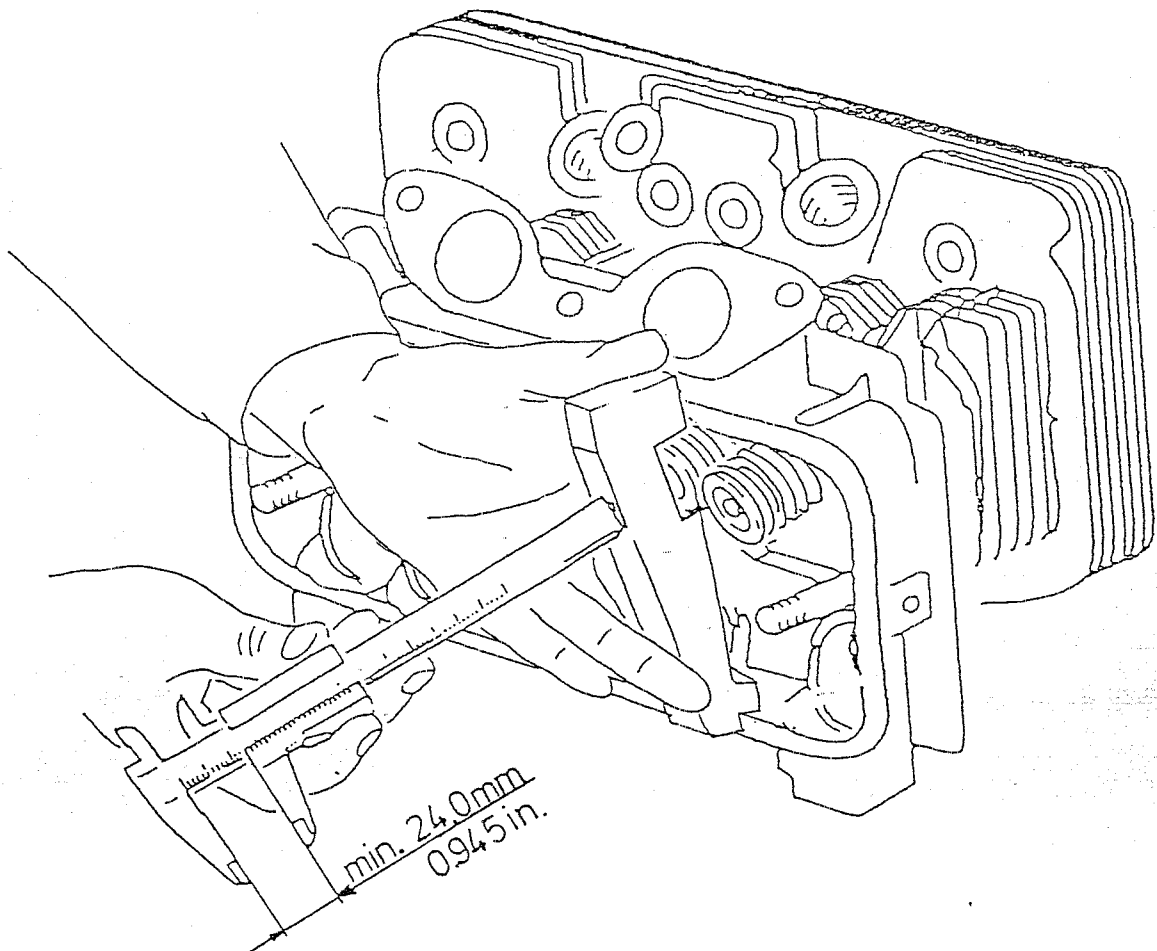
- Procedure:** After 500 to 600 hours operation time, it may occasionally occur, that the valves or the valves seat rings are pounded. To prevent excessive wear or damage, a regular inspection of the cylinder head valve seats is provided as a precautionary measure.

3. Remove L/H and R/H rocker arm assemblies.
 4. Position measurement device (P/N G2500-W1-630) above each valve as shown in the sketch below and measure distance to the end of the valve shaft using a depth gauge. This distance must be **minimum 24.0 mm / 0.945 in.** for inlet and outlet valves. If the minimum distance is reached, the affected cylinder heads have to be exchanged immediately.

- Remarks:**
1. The inspection can be performed by an authorized aviation workshop and has to be certified in the log book by an authorized inspector.
 2. If the distance measured in workstep 4. is **less than 24.5 mm / 0.965 in.**, the inspection has to be repeated during every 100 hours inspection.
 3. If you have sold your motorglider in the meantime, would you kindly pass this information on to the new owner and forward his name and address and aircraft S/N to us.
