Subject: Inspection of the BENDIX-magnetos at the GROB 2500 engine

Concerning: G 109B, as of S/N 6200

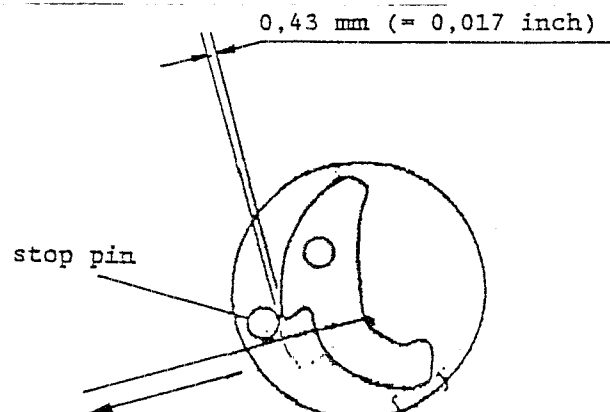
Procedure: During engine inspections too less clearance between flyweights and stop pin has been found.

a. Pull the flyweight outwards by using a proper tool (for example a stiff, bended wire), measure the clearance and note the value. The clearance must have a minimum of 0,43 mm (=0,017 inch).

b. Repeat the measurement for the second flyweight.

Warning: If the clearance is less than 0,43 mm (=0,017 inch), further operation of the engine with this magneto is not allowed, and the manufacturer must be contacted immediately.
