**Subject:** Inspection of the trim tab hinges

**Concerned:** G 115/ G 115A/ G 115B, all S/N's  
G 115C, G 115C2, G 115D, G 115D2, all S/N's

**Background Information:** It was reported to GROB, that on some aircraft of the series G 115C2, cracks were found in the area of the elevator trim tab hinges. As a precautionary measure the trim tab hinges of the G 115 series must be checked for possible cracks and tight fit in the laminate. The cracks could be caused by the trim tab end is touching the upper elevator shell at fully deflection.

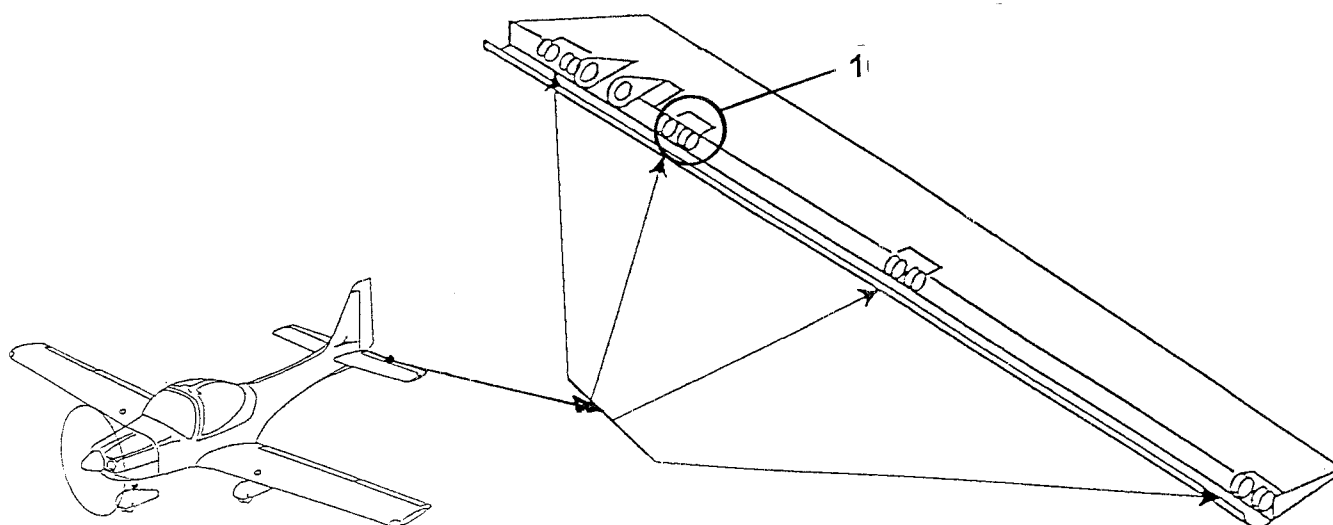
1. The trim tab hinges (qty. 4, as of S/N 82078 qty. 5) must be checked visually (perhaps using a magnifying glass, 10 times magnification) for cracks and tight fit in the laminate (especially in the area of the marked hinge, item 1, because the cracks were found in this area) and the result must be filed in the attached "**Inspection Record**". In any case of doubt the trim tab has to be removed according to MM Chapter 55-20-00 and must be checked. Damages must be repaired according to the Repair Instructions No. 1078-75.

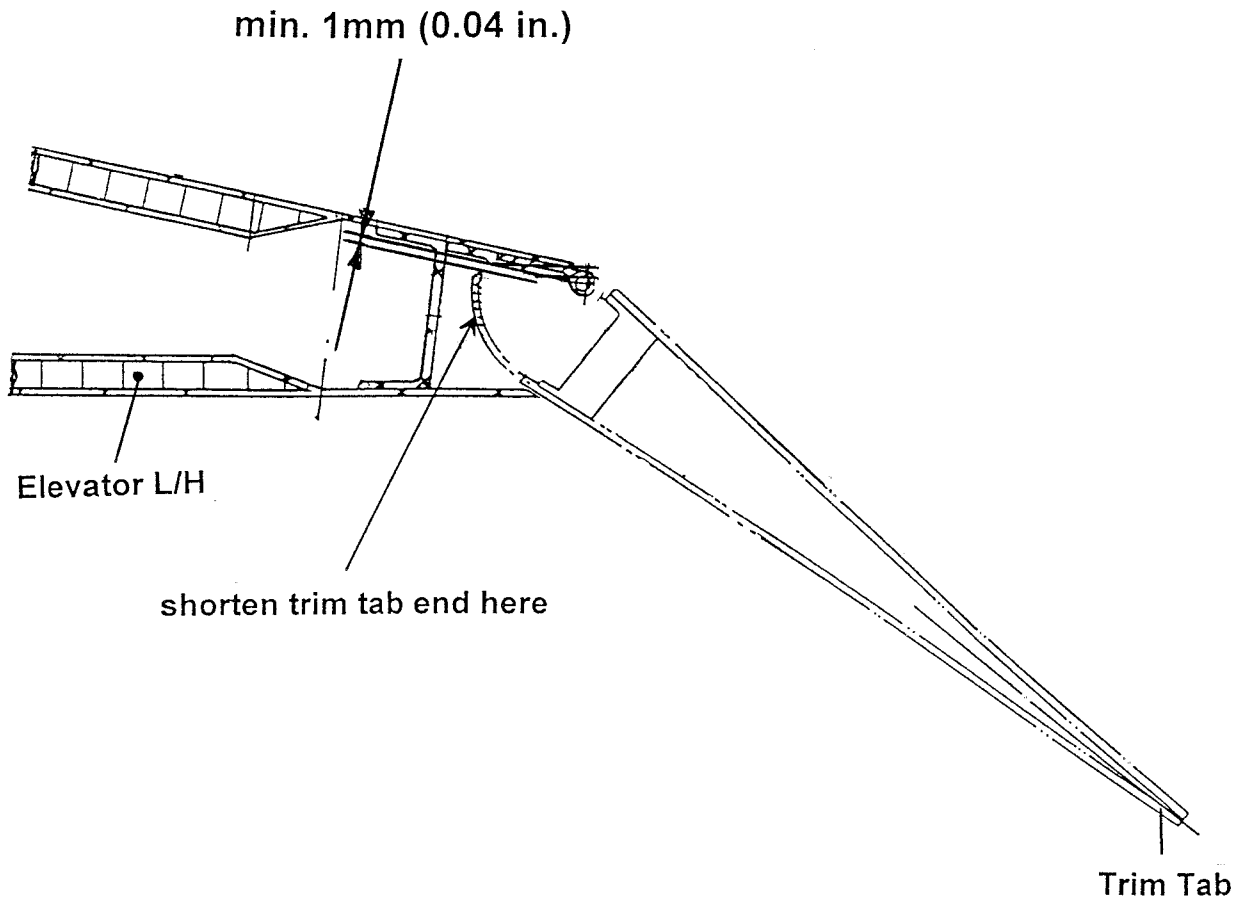
2. Check, whether the trim tab end touches the upper elevator shell as follows:
  - trim the trim tab to fully nose up
  - measure deflection and note value, if necessary adjust (refer to the corresponding MM)
  - push elevator fully
  - check whether **minimum 1 mm (0.04 in.) gap** is ensured between the end of the trim tab and the upper elevator shell using a pocket lamp and thickness gauge
  - if no or a too small gap is found, remove the trim tab and shorten the end of the trim tab as far as minimum 1mm (0.04 in.) gap exists
  - check weight and residual moment of the trim tab according to the MM Chap. 06-00-00 and file the values
  - install trim tab according to the MM Chap. 55-20-00 and check or adjust deflection according to the MM Chap. 06-00-00
