SERVICE BULLETIN NO. MSB1078-163/1

ATA-Code: 20-10 Standard Practices - Airframe
 57-10 Wing Structure

G 115C/D/E/EG

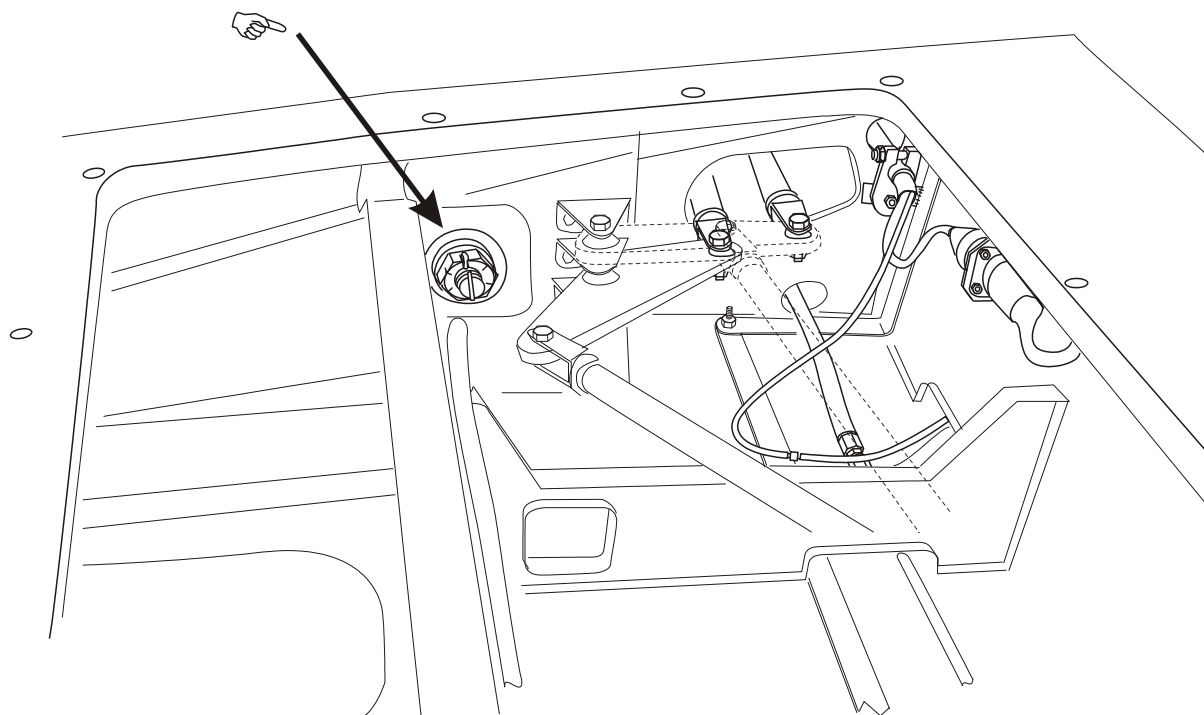
Fig.1

During final assembly of a new series production aircraft it was revealed, that the corresponding Maintenance Manuals give different and incorrect torque values for the wing shear force fitting nuts, although the approved design data give the correct value.

Therefore the nuts at the affected aircraft may not have been tightened to the correct value during maintenance and repair activities and as precautionary action the torque has to be checked and corrected, if required.

- 1.8.1. Ensure that the aircraft is safe for parking I.A.W. MM chapter 10-10.
- 1.8.2. Remove the baggage compartment panel to get access to the RH and LH rear wing shear bolts (Fig. 1) I.A.W. MM chapter 25-10.
