SERVICE LETTER NO. SL 115-055

ATA-Code: 73-10 Engine - Fuel And Control
Engine Driven Fuel Pump

SERVICE BULLETIN

SUBJECT: Diaphragm-Type Fuel Pump Replacement

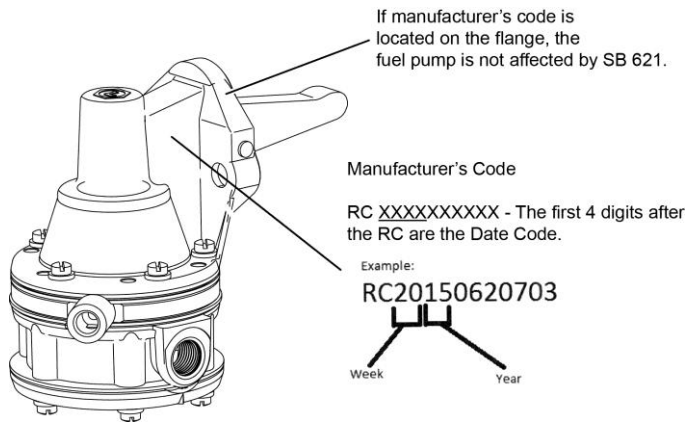
NOTICE: Each fuel pump has a 13-digit alphanumeric manufacturer’s code, which begins with two letters as shown in the example in Figure 1. The alphanumeric characters in the manufacturer’s code and its location on the fuel pump will help identify the fuel pumps affected by this Service Bulletin. The first two characters in the example manufacturer’s code RC20150620703 in Figure 1 are **RC**. The next two numbers **20** identify the manufacturing week of the year as **20** and **15** is the year. The manufacturer’s code is on the fuel pump flange or on the web as shown in Figure 1. If the manufacturer’s code is on the flange as in the example in Figure 2, the fuel pump is not affected by this Service Bulletin.

Figure 1
 Manufacturer's Code Location on
 Fuel Pump P/Ns 62B26931 and LW-16335

1. If the fuel pump is Lycoming part number 62B26931 or LW-16335.
2. If the manufacturer's code is not on the flange but is on the web or other parts of the fuel pump.
3. If the fuel pump has **RC** (Figure 1) as the first two letters of the manufacturer's code.
4. If the manufacturer's code identifies the fuel pump as manufactured before, up to, and including the 25th week of 2015.

If any fuel pump meets **all** the criteria above, remove the fuel pump from the engine or from the spares inventory and:

- A. Review your records to identify shipping dates of the serial numbers of any of the affected fuel pumps.
- B. Return all affected fuel pumps to Lycoming Engines with a copy of this Service Bulletin and file a warranty claim per the warranty procedure herein.
- C. Record removal of the fuel pump installed on the engine in the engine logbook.

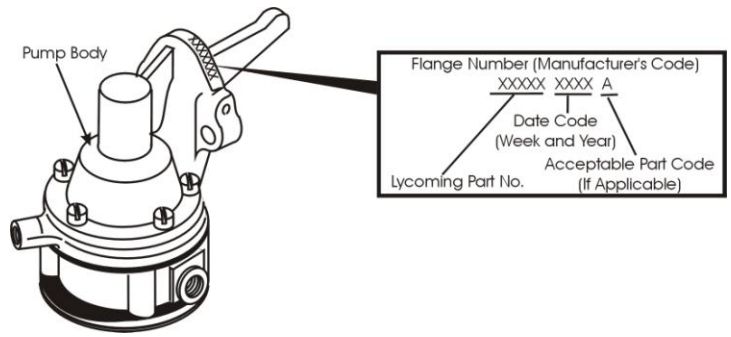
Figure 2
 Manufacturer's Code on the Flange
 (Fuel Pump Is NOT affected by SB-621)
