## SERVICE BULLETIN NO. MSB817-65

ATA-Code: 25-10 Flight compartment furnishing  
Inspection of the seat harness

## SERVICE INFORMATION LETTER

**SUBJECT:** Quick Release Box (QRB) Part Number SL 40.3 and SL 40.3X

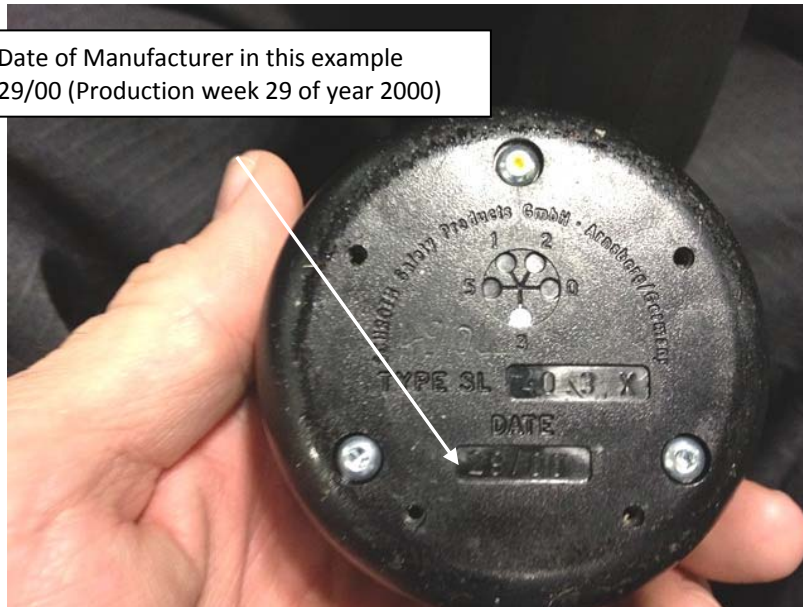
The functional check has to be performed on QRBs produced prior to and including week 47/2004. The date of manufacture can be seen on the bottom side of the QRB for the SL 40.3 (see photograph below).

Date of Manufacturer in this example  
29/00 (Production week 29 of year 2000)

For the SL 40.3X the buckle pad needs to be removed first to see the bottom of the QRB and the date of manufacture therewith. It is recommended to perform the functional check on all QRBs in question as the disassembling of the pad takes longer than performing the functional check.

Should a latch do not release freely during the functional test of the buckle it is recommended that the QRB be removed and returned to the manufacturer for repair.

The QRB can be separated from the restraint by pushing the pin which secures the permanent fixed latch. Use a needle with a diameter of 2mm and push the pin through the hole at the actuator of the QRB. Pull out the latch. To insert the latch follow the same procedure. For more detailed information see CMM 25-24-01, Iss.02, chapter 4.1.
