Subject: Replacement of fuel hose on firewall

Concerning: 1. G 115 s/n 8011,8018,8036,8039,8051,8053,
8056,8063,8064
2. G 115A s/n 8090 - 8109

This installation instruction no. 1078-16 is issued against the Service Bulletin TM 1078-16 and contains instructions for the replacement of the fuel hose on firewall.

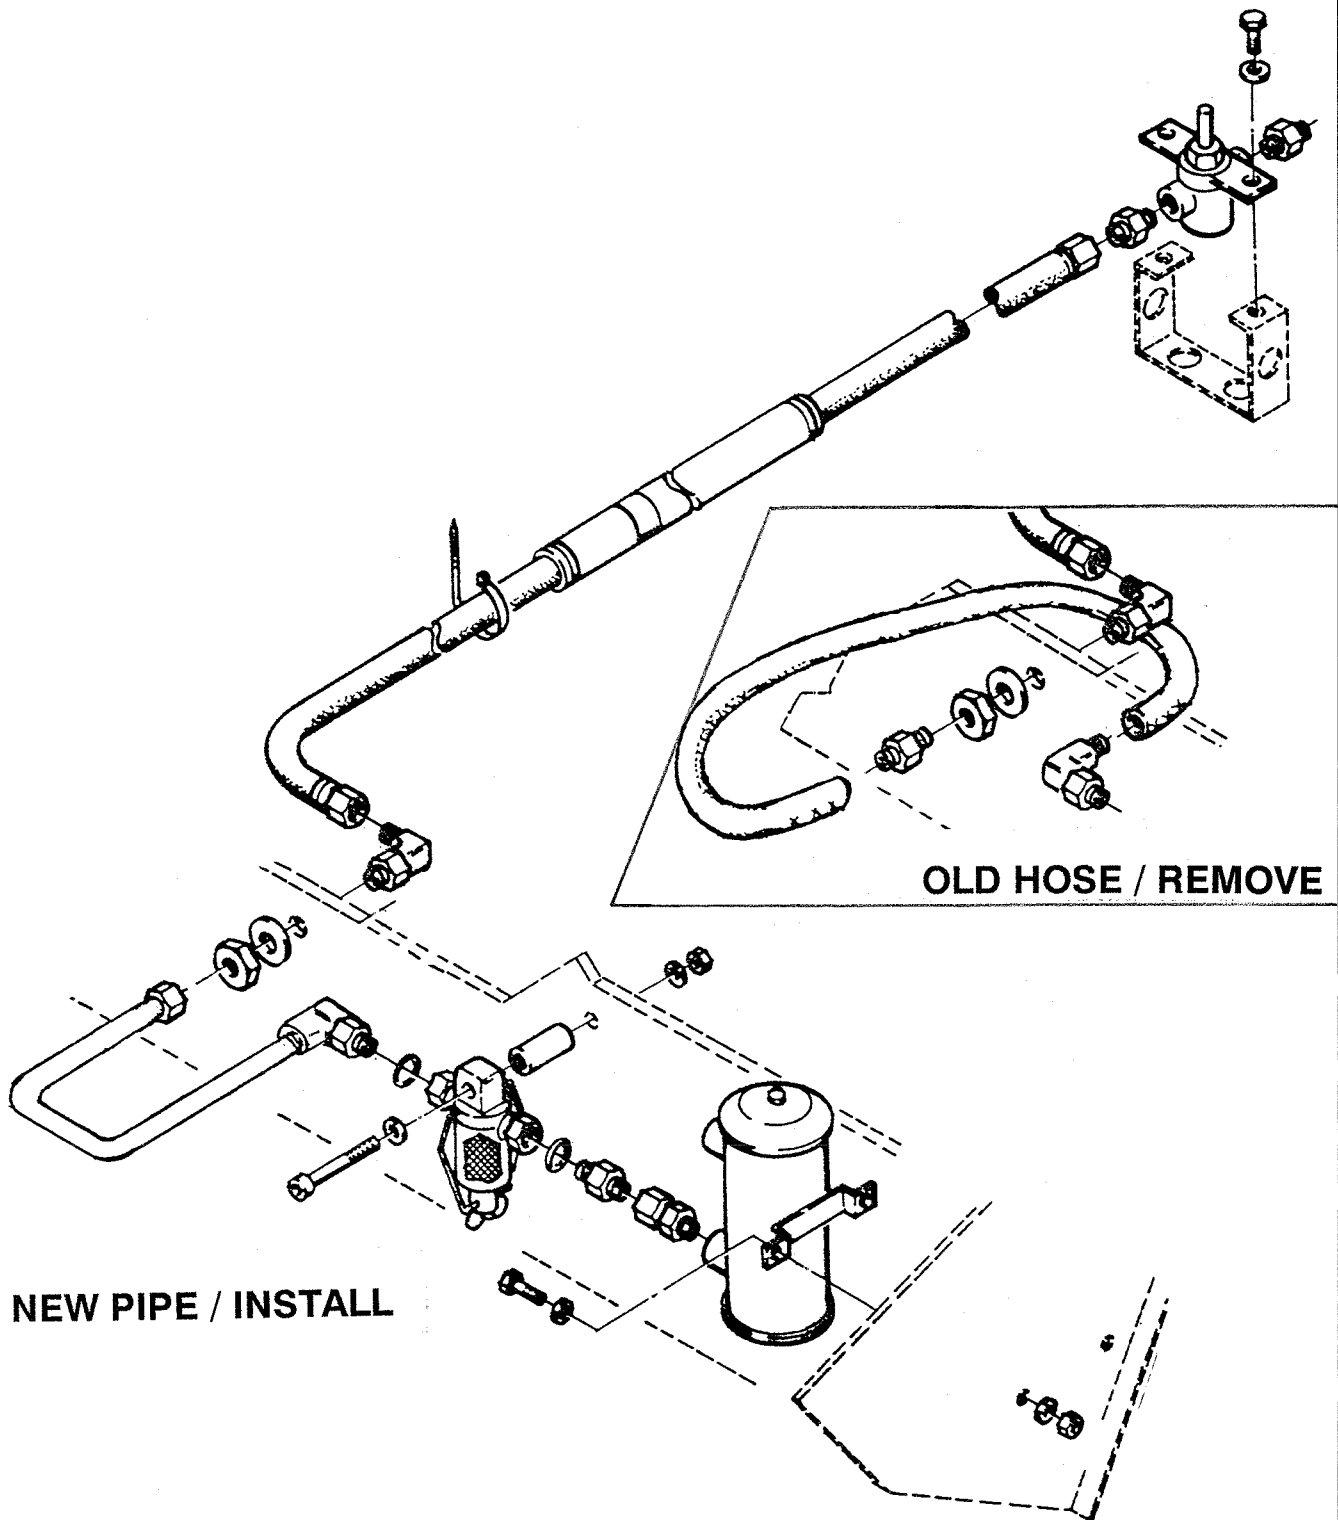
1. Remove cowling according to Maintenance Manual G 115 chapter 71-10
2. Close fuel cock
3. Remove firewall fuel hose
4. Install modified fuel pipe
5. Check fuel system for leakage
6. Install cowling
